ANEXO FOTOGRÁFICO

Fecha de Inspección:	Nombre de la Unidad Fiscalizable:	Dirección:	Registro:
29 de mayo de 2020	Desabolladura Varona	Ogana N° 1599, Coyhaique	NPA

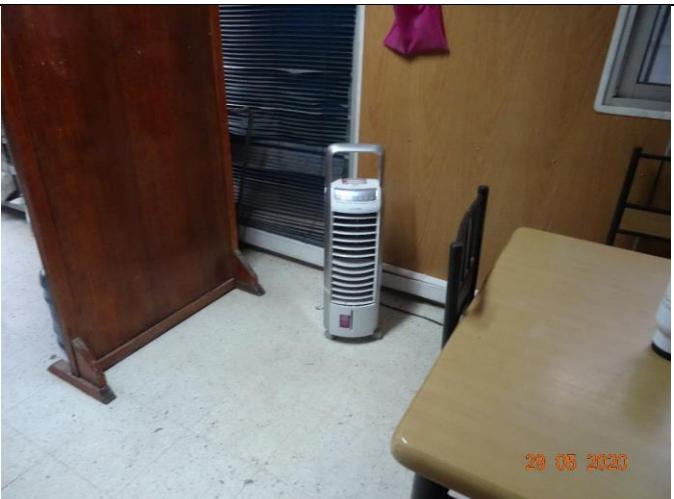
A photograph showing the interior of an office. A white electric heater stands on the floor next to a large wooden cabinet. To the right, there's a wooden desk and chair. A window with a dark frame is visible in the background. The date '29 05 2020' is overlaid in orange at the bottom right of the photo.
Descripción del medio de prueba: Calefactor a parafina encendido en la oficina administrativa.	Descripción del medio de prueba: Calefactor a eléctrico apagado en oficina administrativa.
